An early 19th Century Satin Birch Beidermeier salon chair with caned seat, ebony stringing and turned front legs

Contents

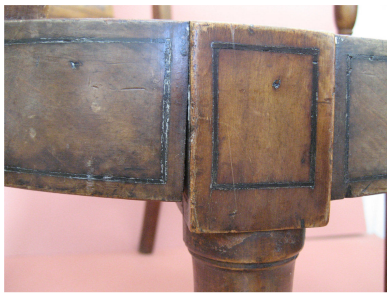
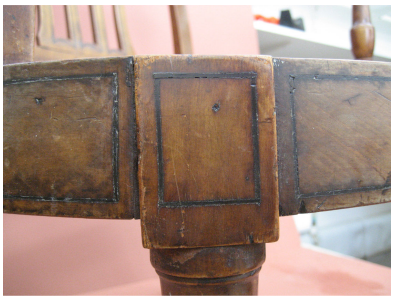
6. PR front leg - Consolidate Joint

There was some slight movement in the PR front leg, and a tapered gap at tenon shoulder that could not be cramped out. It was decided that the least invasive consolidation method was to insert a piece of Satin Birch carved to fit the opening. The piece was glued in with Fish Glue, using masking tape to control glue application. A final coat of shellac and earth pigment completes the blending in.

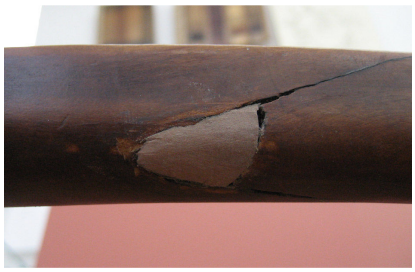
7. PL arm - Chip missing Decorative 1/ Item 3

There was some natural splitting in the PL arm, and a section has been lost, judging by the patination of the cleaved surface this happened some time ago. It was decided to fit a splice onto the old surface without disturbing this patination.

A piece of Plasticine® was pushed into the cavity and used as a guide for carving the inside mating surfaces of our “conservation splice”. A piece of Satin Birch was carved to this shape and glued into place using Fish Glue and cramped into place with Sellotape®
.

The section was then trimmed in with chisels and finished with a goose-neck cabinet scraper. The new timber was stained with water stains, the small gaps were stopped with wax, and a final coat of shellac and earth pigment completes the blending in.

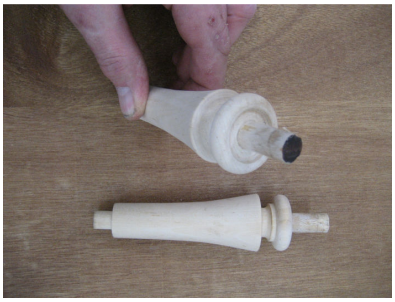
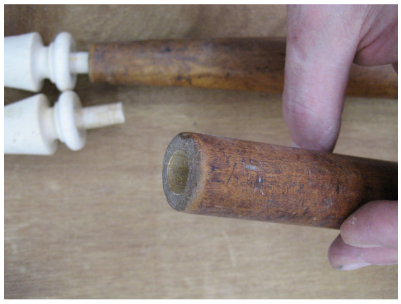
9. Replacing the missing leg sections

The chair has been cut down at some point, and after research and measurement, sections of pine were turned to simulate how the leg would have looked if the taper had continued to the correct height. The sections were then quickly coloured in to show visually how that would have looked had the taper continued.

Clearly this is incorrect and research will now guide the choice of replacement foot at the front – the rear legs will continue as they are simply oval in cross –section.
.

Starting from “green” Birch, a log was cleaved into billets before rough turning to size to facilitate rapid seasoning. Once the moisture content reached 12% the front feet were turned with tenons and a recess to allow the original surface to be retained on the base of the remaining front legs. This surface was treated with a barrier coat of hide glue before being set into a bed of epoxy consolidated with micro-balloons, and the tenon joint was glued with hide glue.
